TECHNICAL INSPECTION REPORT

U.S.S. NEW YORK (BB34)

TEST ABLE

OPERATION CROSSROADS
SPECIAL WEAPONS PROJECT

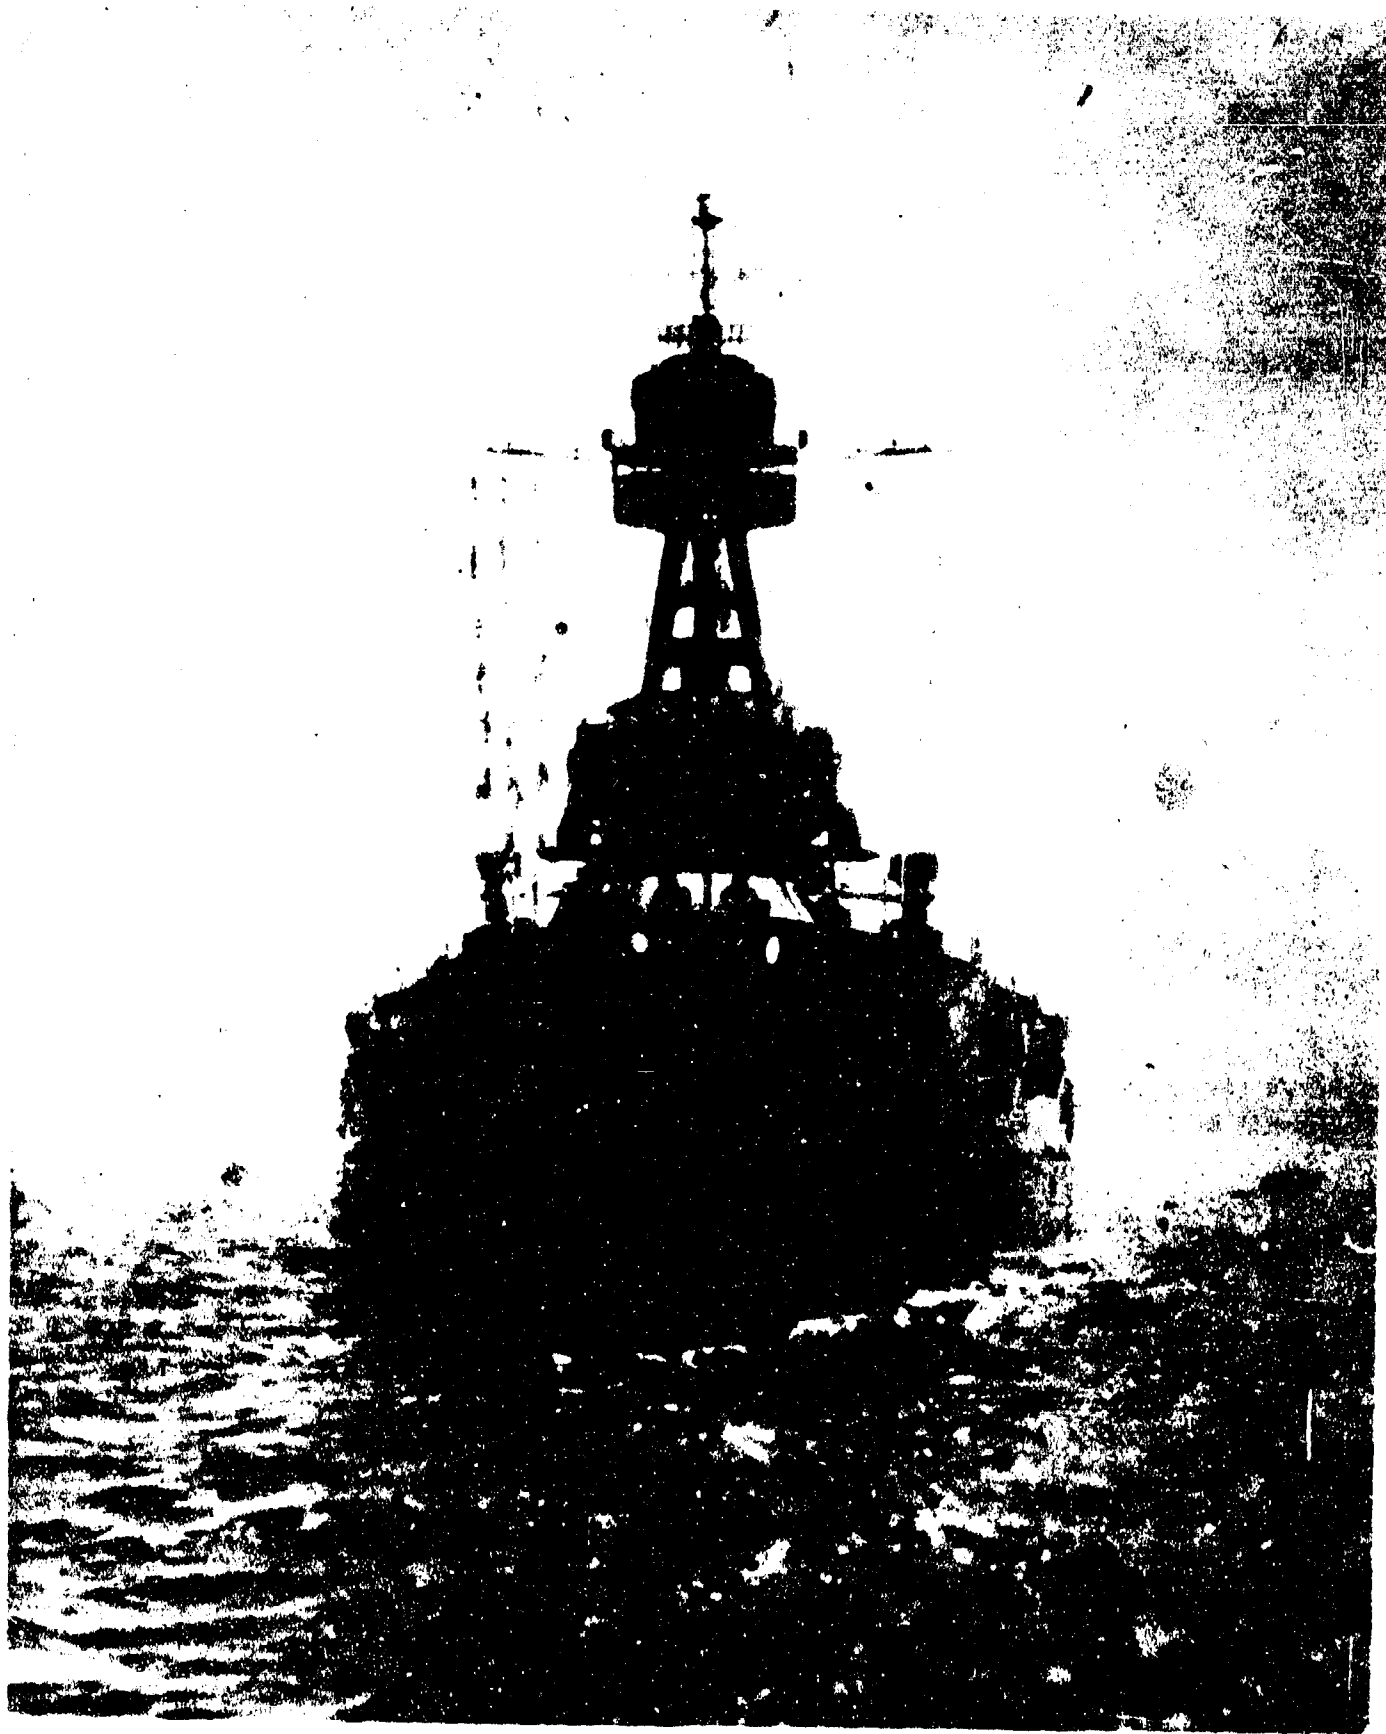
AA-CR-227-50-50. View from dead ahead after Test A.

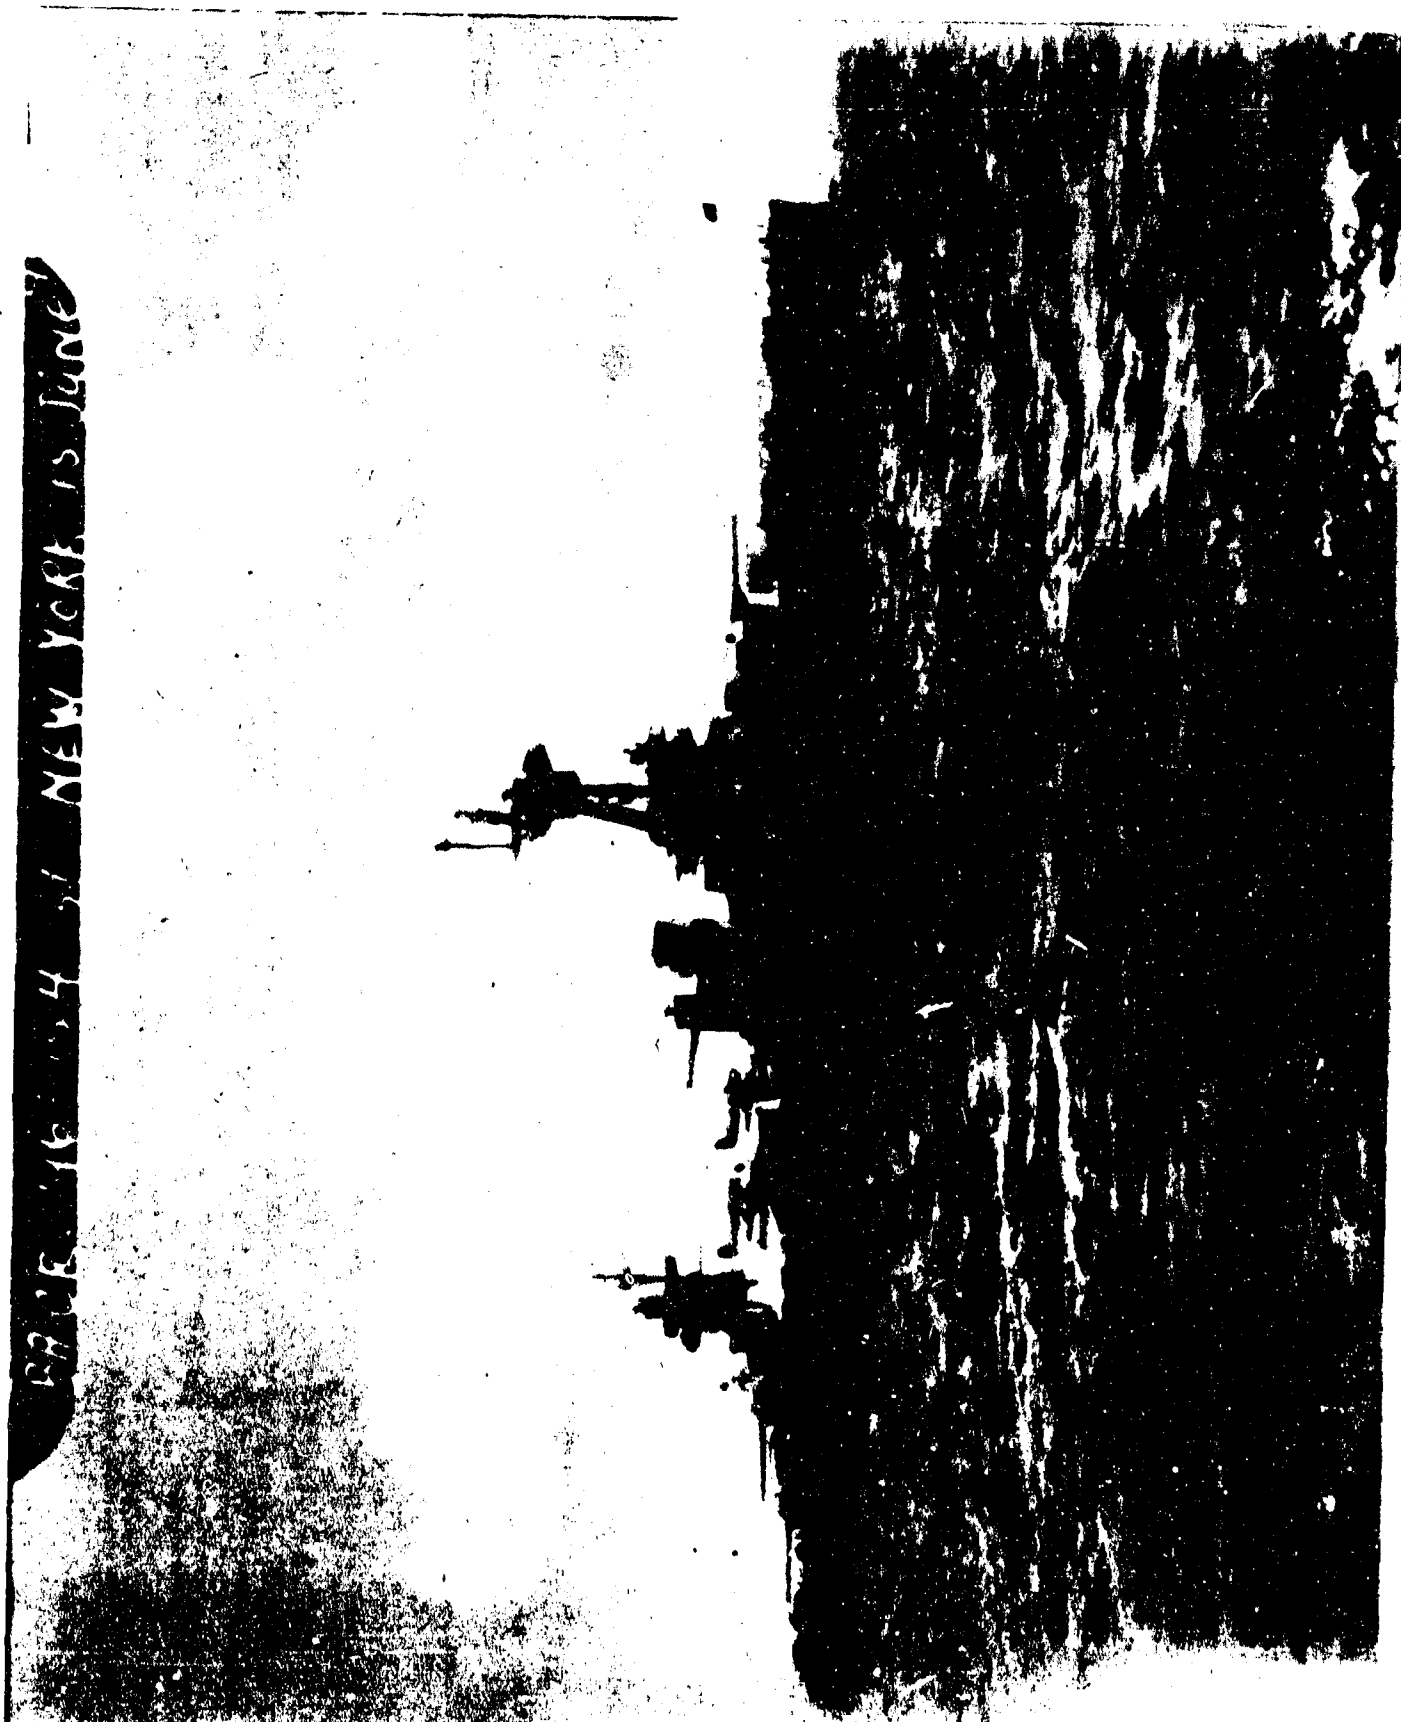
BA-CR-196-154-31. View on starboard beam before Test A.

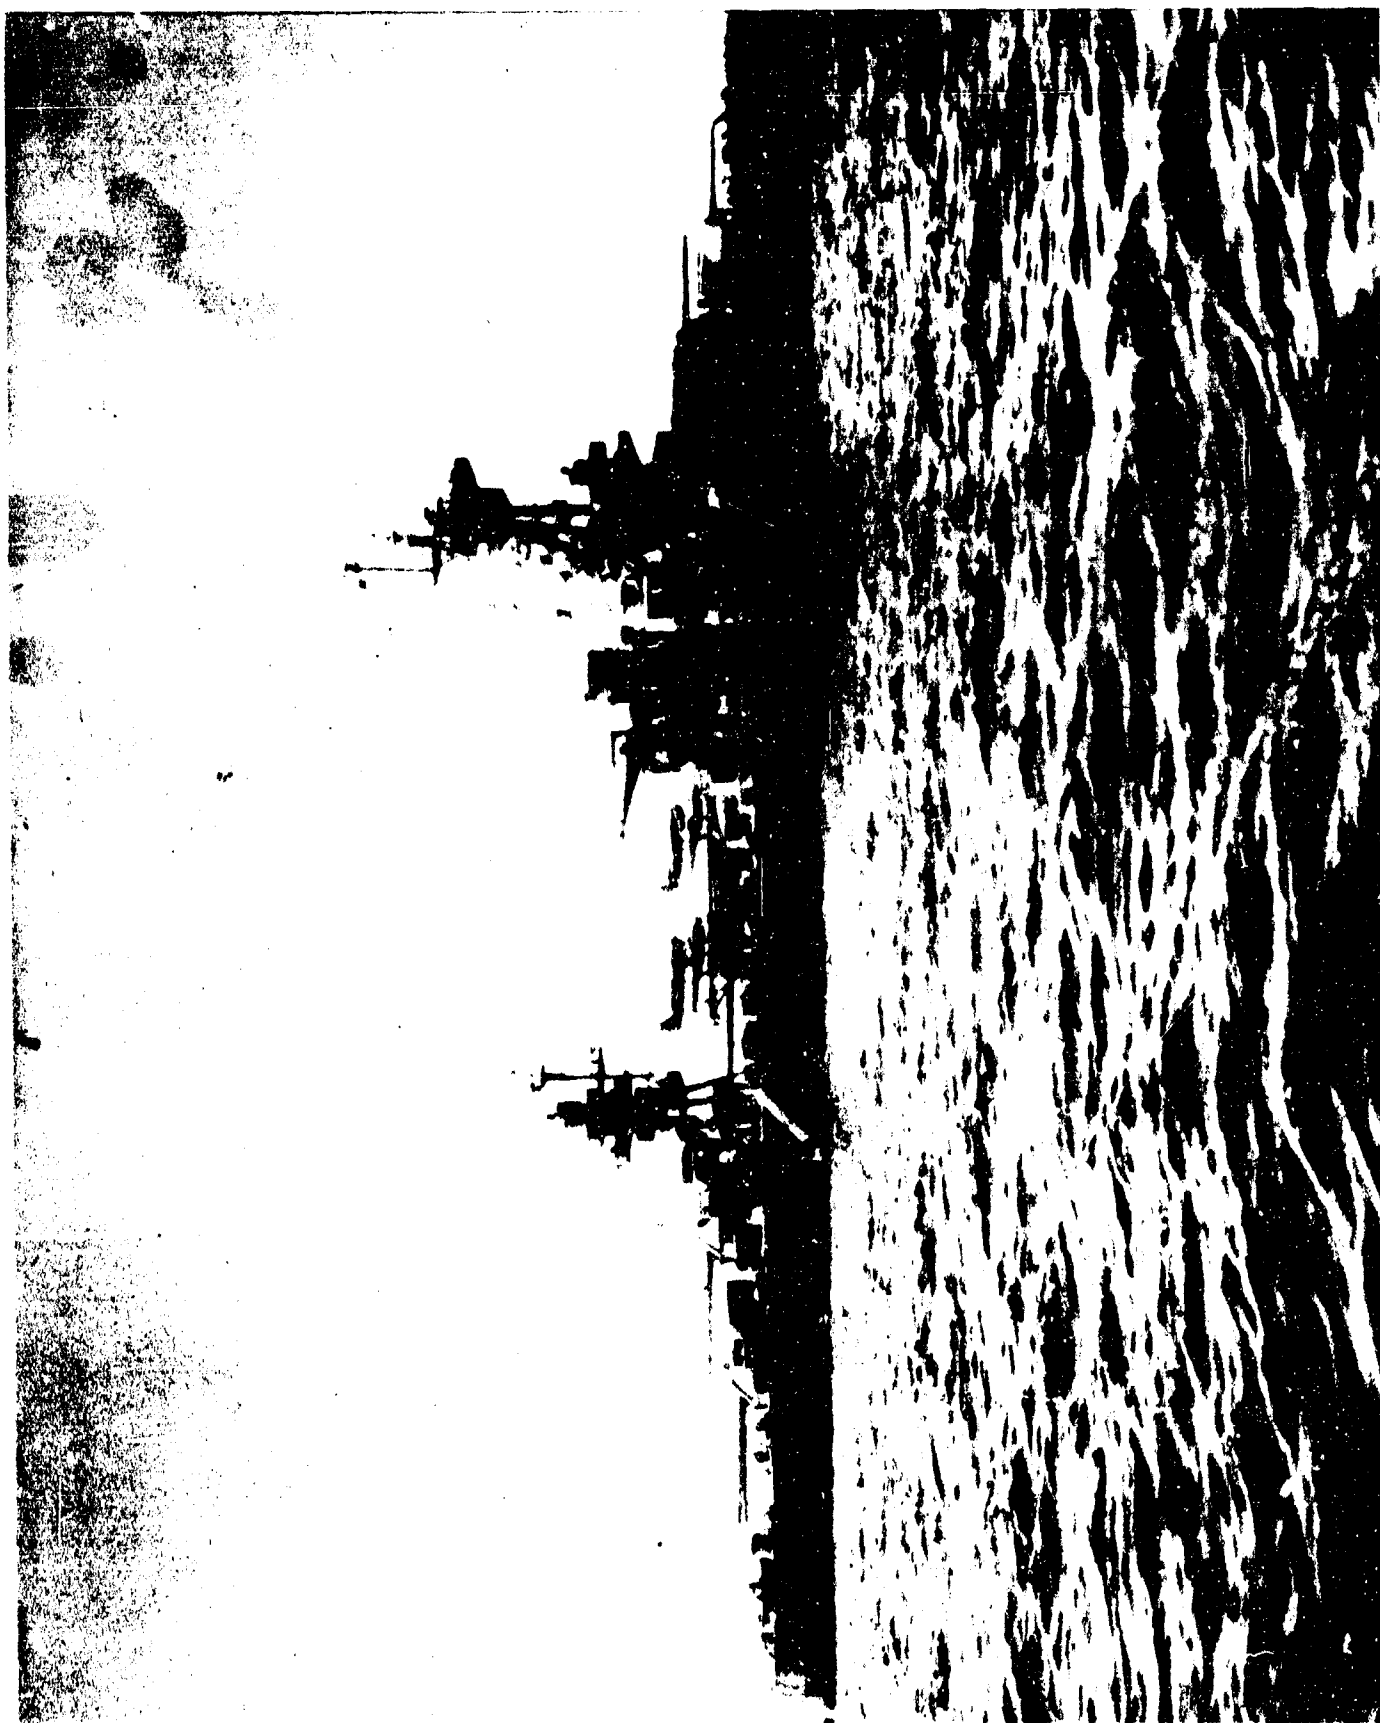
AA-CR-227-50-48. View on starboard beam after Test A.

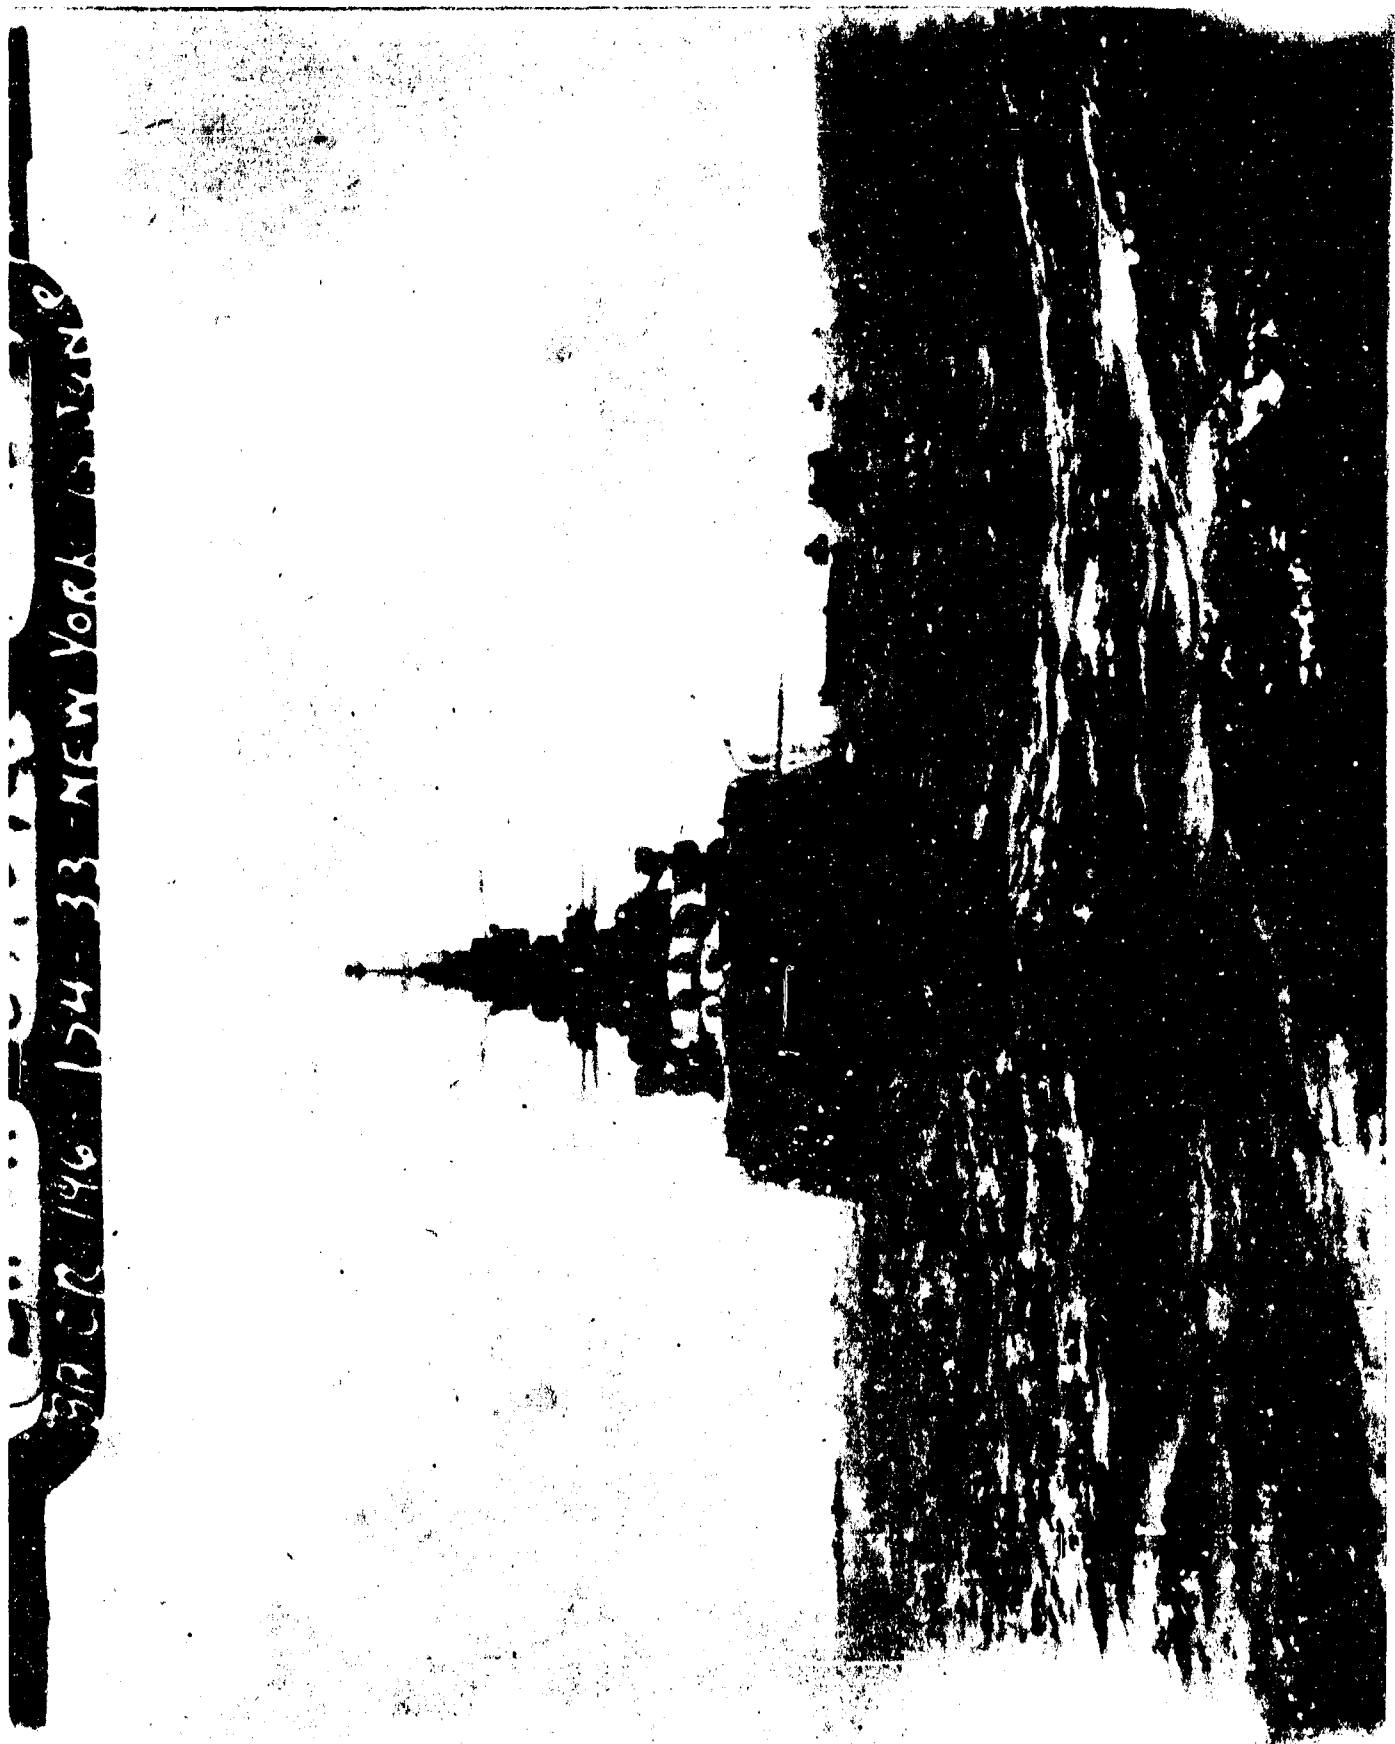
BA-CR-196-154-33. View from dead astern before Test A.

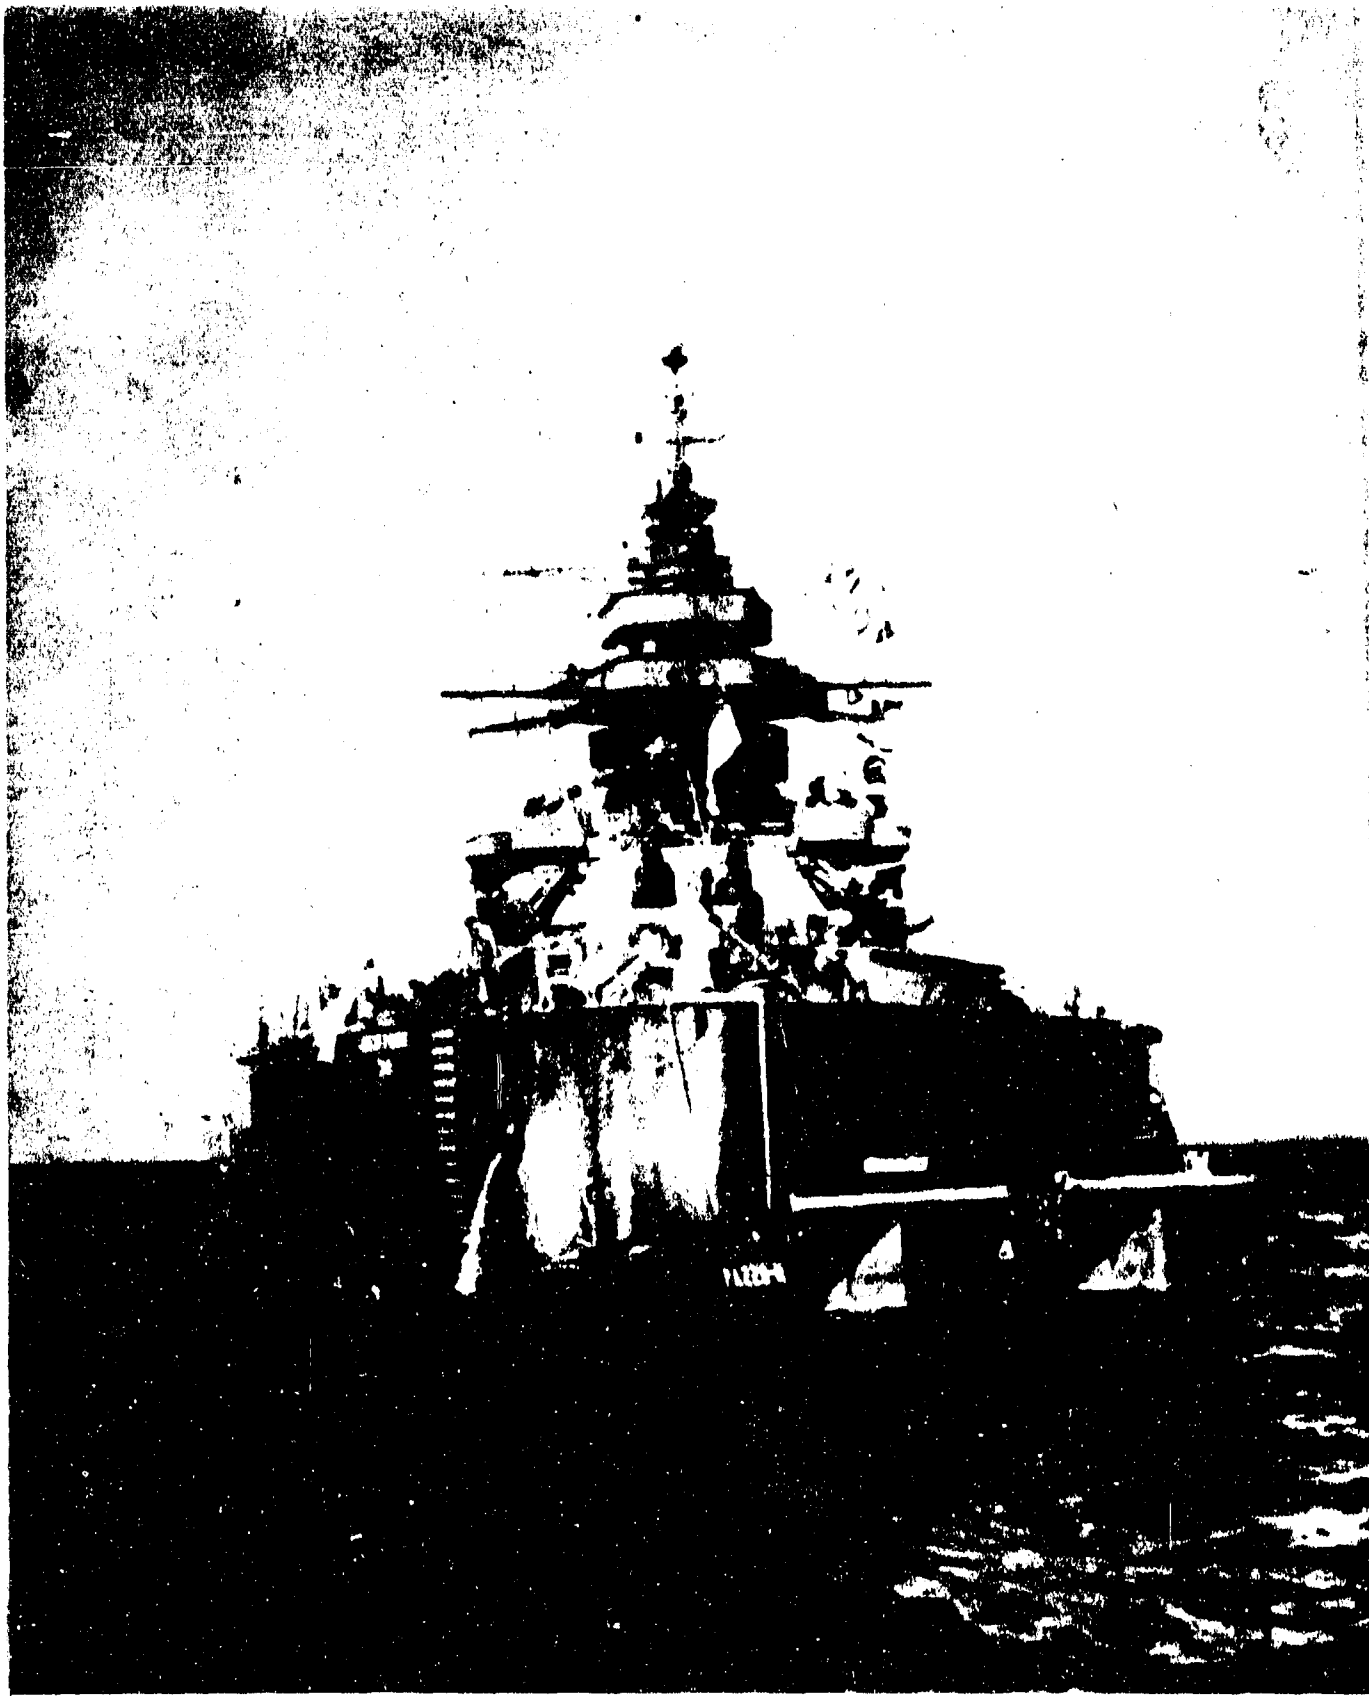
AA-CR-227-50-54. View from dead astern after Test A.

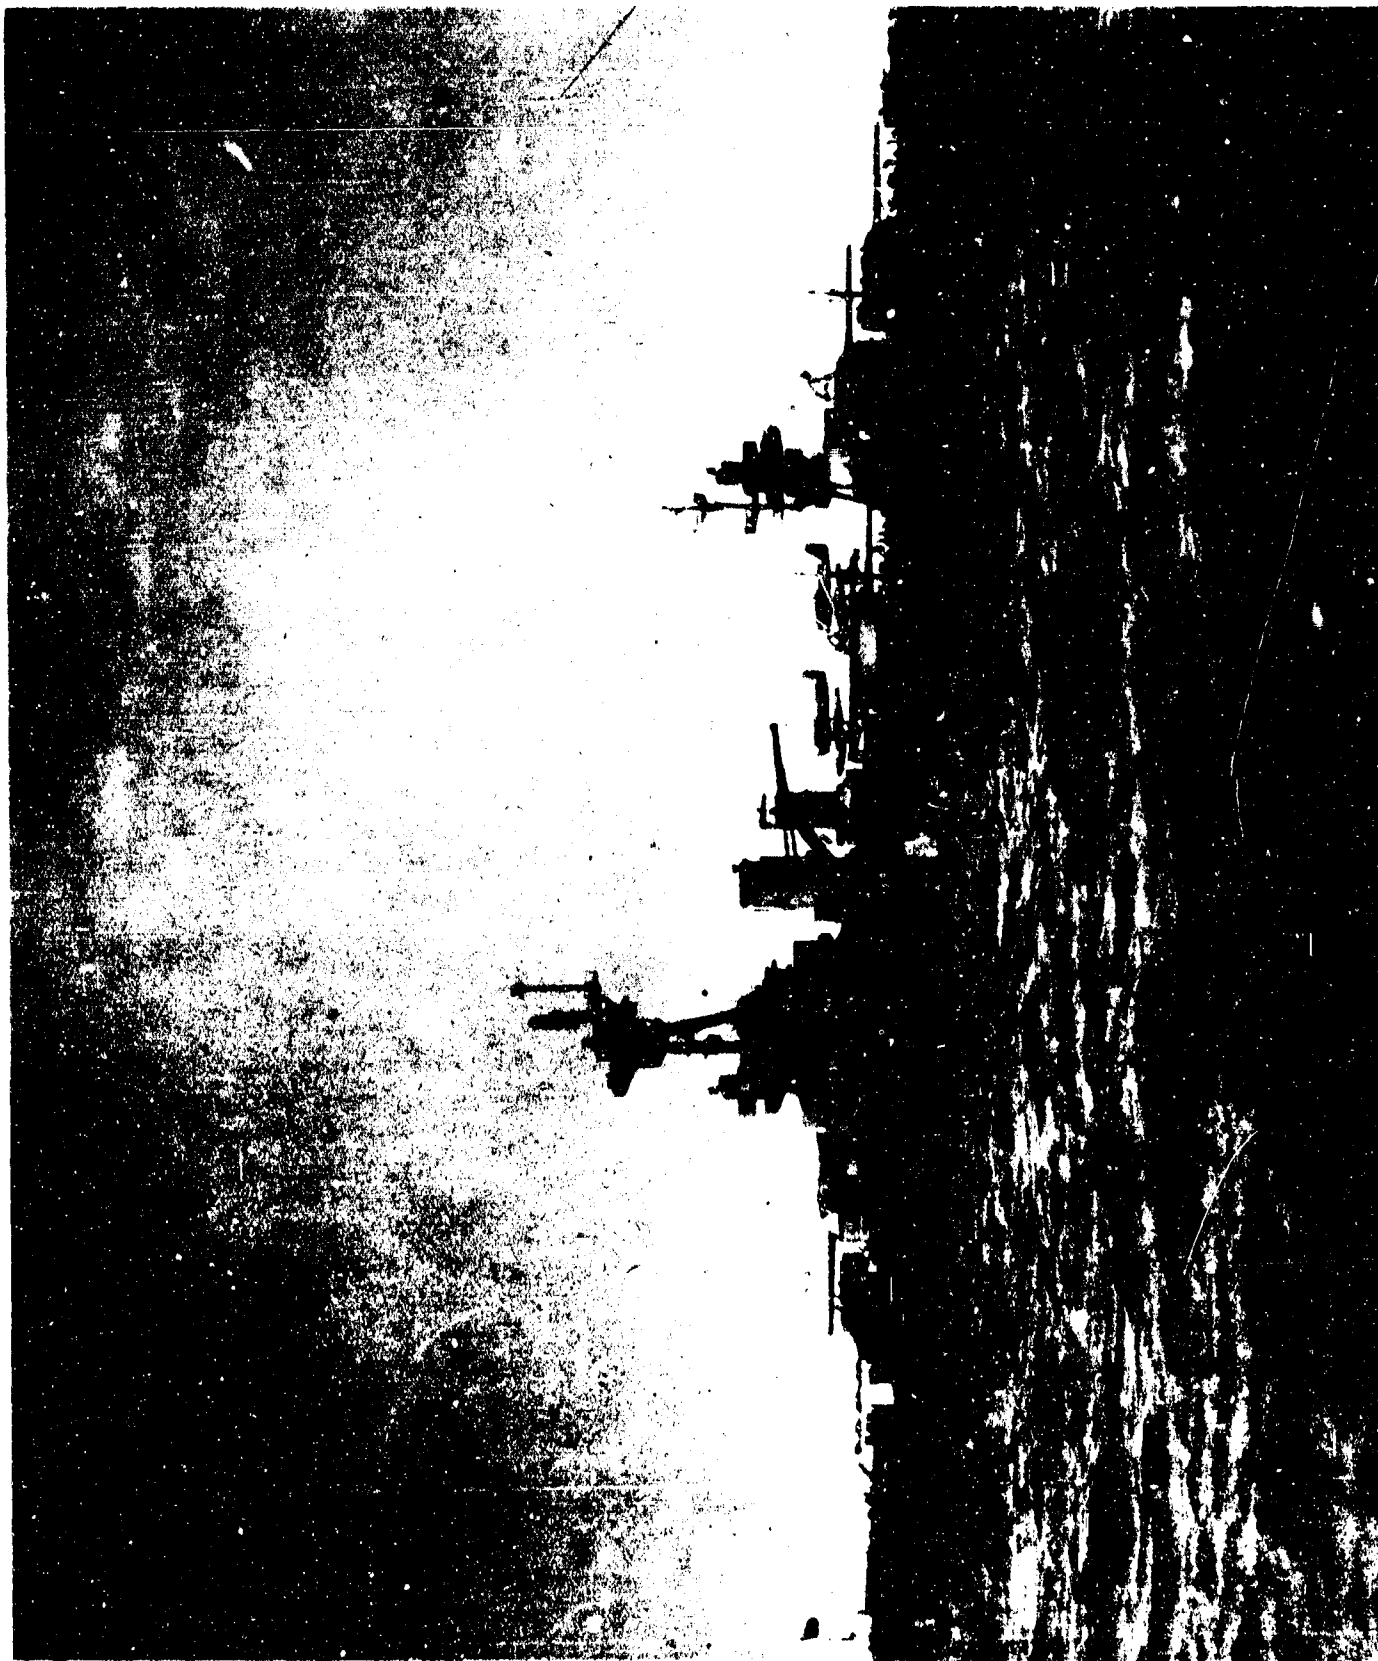
AA-CR-227-91-49. View on port beam after Test A.

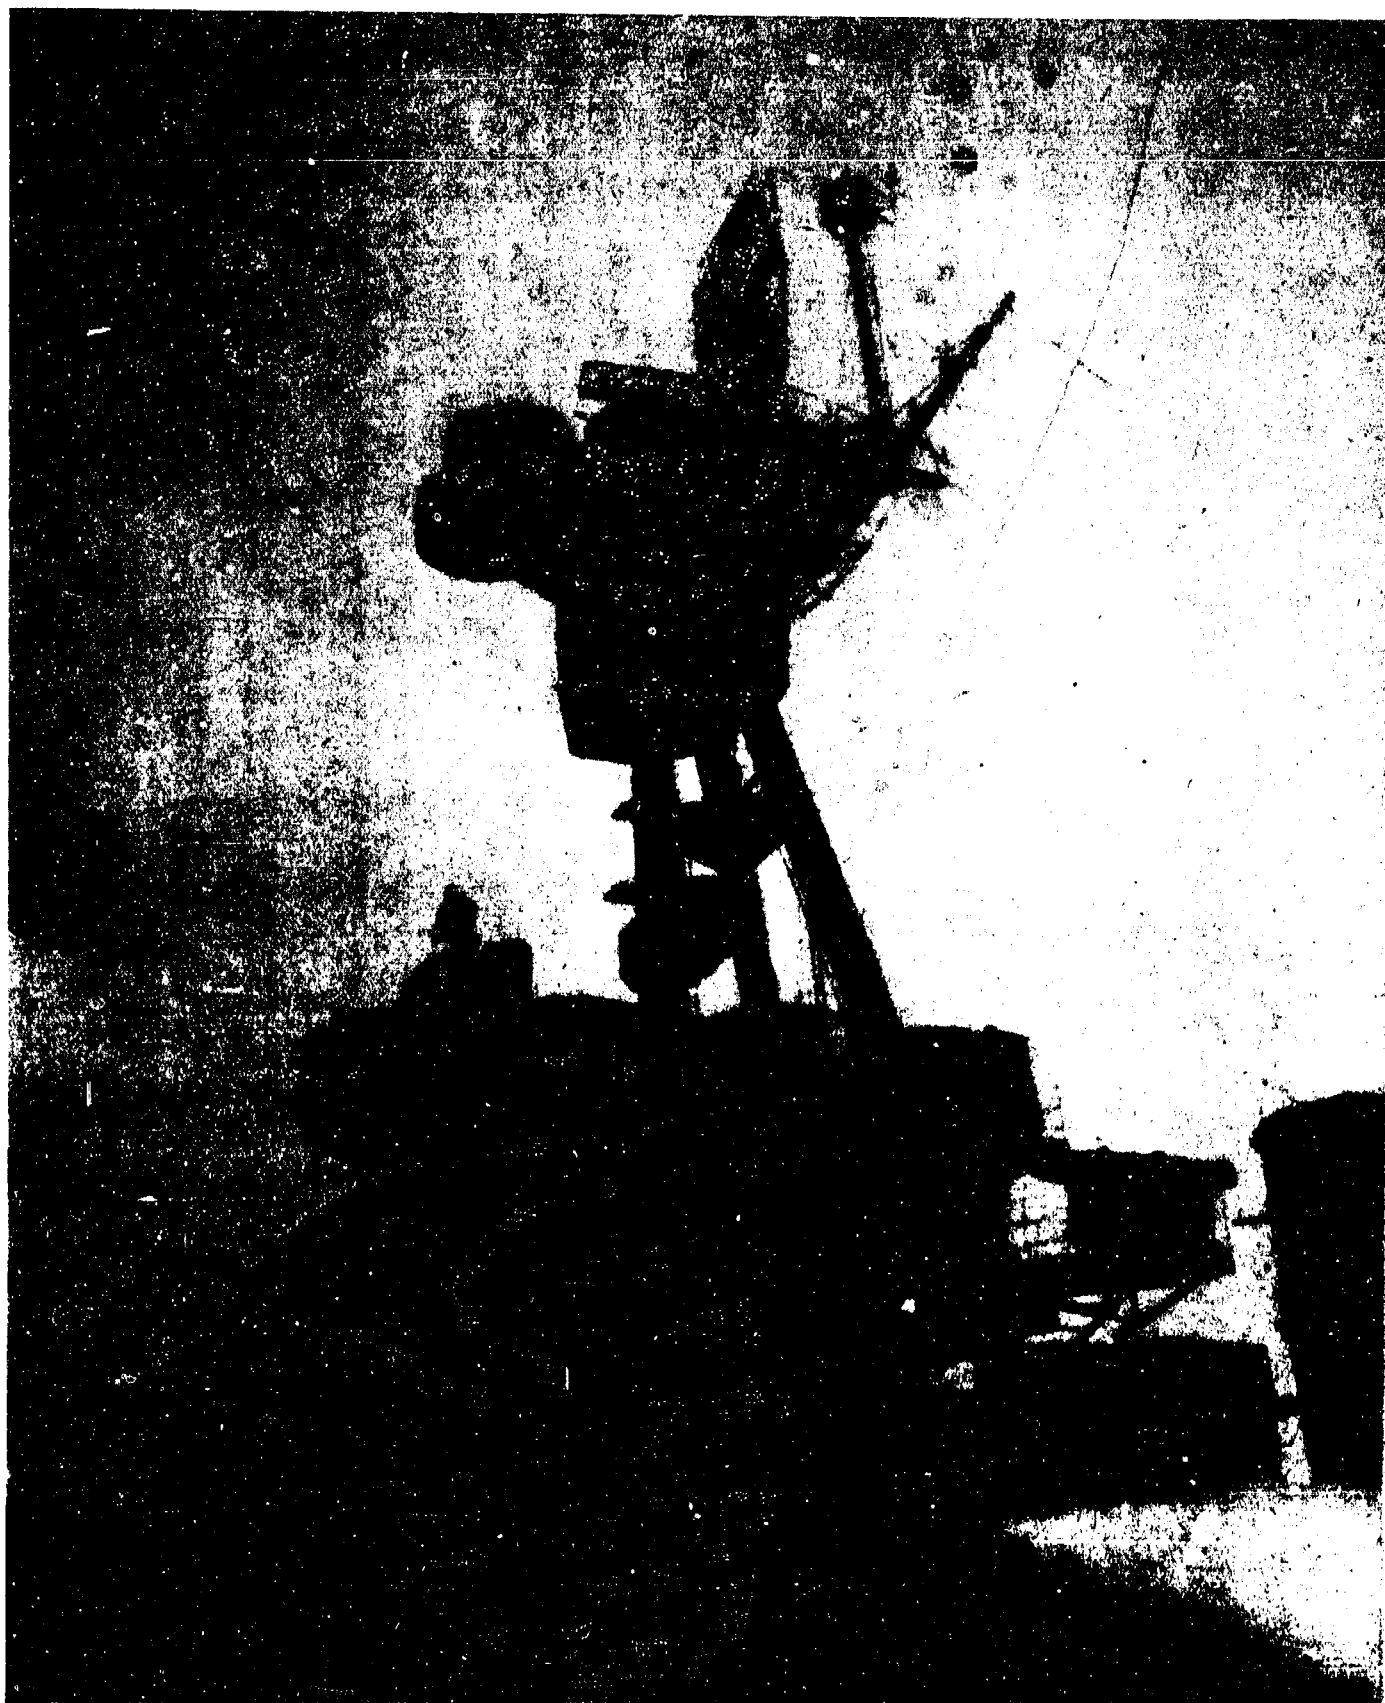
AA-CR-62-1831-9. Close-up of forward superstructure, port side.
